Deck, balcony and window safety

A guideline for the use, inspection and maintenance of decks, balconies and windows

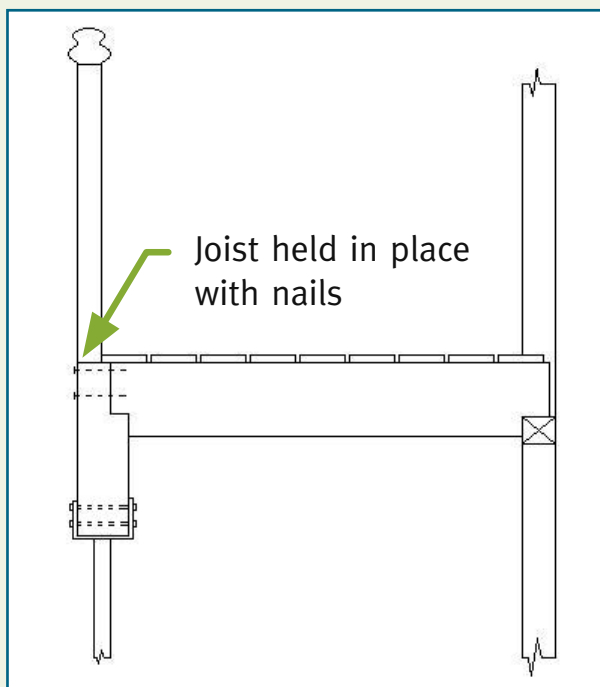
Figure 2: Pre-1940s deck construction with a cogged out beam holding the joist with nails

Figure 2 shows a typical construction method for pre-1940s decks. The beam (or bearer) is cogged out to hold the joist. The joist is held in place with nails. This was the joining method used on the collapsed deck.

In this type of construction method the ends of the joists are concealed by the bearer in the area where the joist rests.

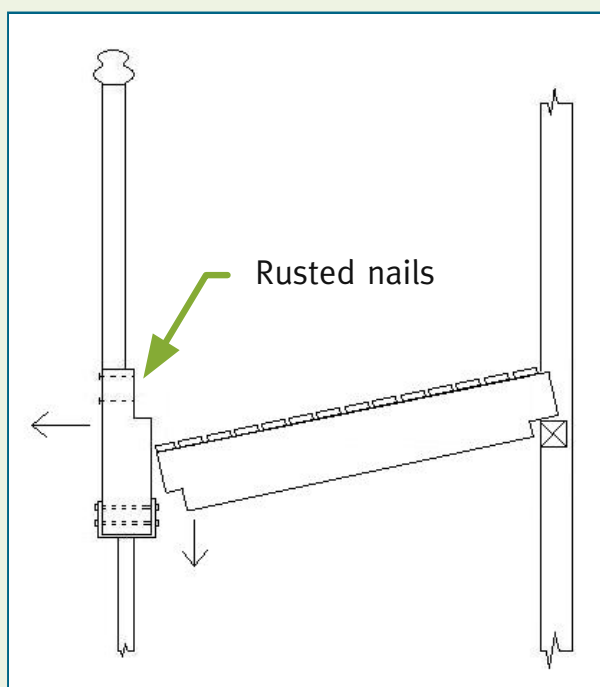
Figure 3: Old nails can rust out causing structure to collapse

Over time, the nails can rust out, the beam can bow outwards and the joist can separate, potentially resulting in structure failure or collapse as shown in Figure 3.

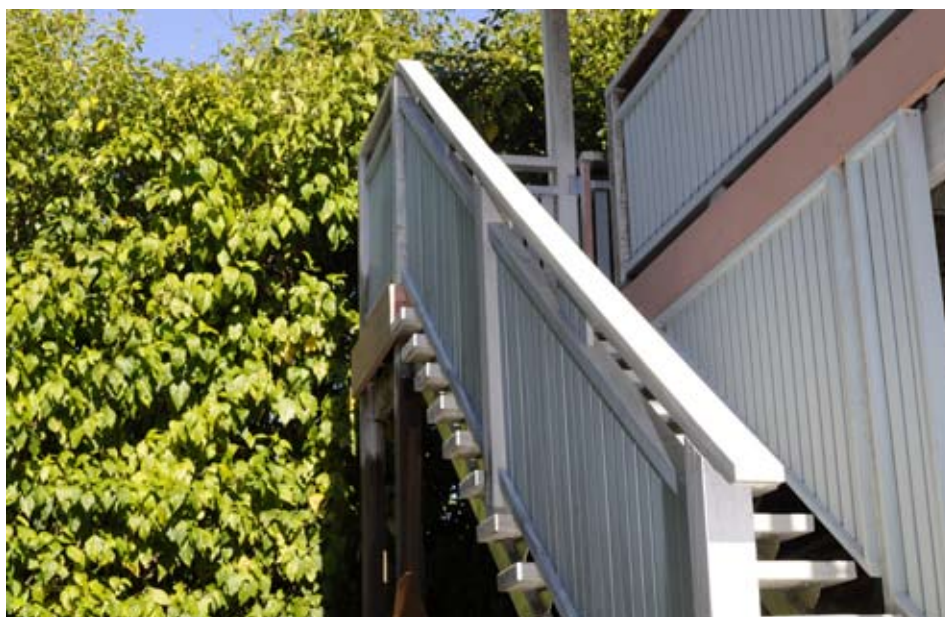
For most stairs, a barrier of at least 865 millimetres high above the ‘nosing’ of the stair treads is required. The ‘nosing’ of the stair treads can be

measured by placing a string line, or straight object, where each stair tread begins, forming a slope. The measurement of 865 millimetres can be taken vertically anywhere along this line to the bottom of the balustrade. As with balustrades for decks and balconies, gaps in balustrades on stairs cannot have openings greater than 125 millimetres. For stairs more than four metres in height, a balustrade must also not have any climbable elements, such as horizontal rails, located between 150 millimetres and 760 millimetres from the floor.

Stairs require a similar barrier to decks and balconies

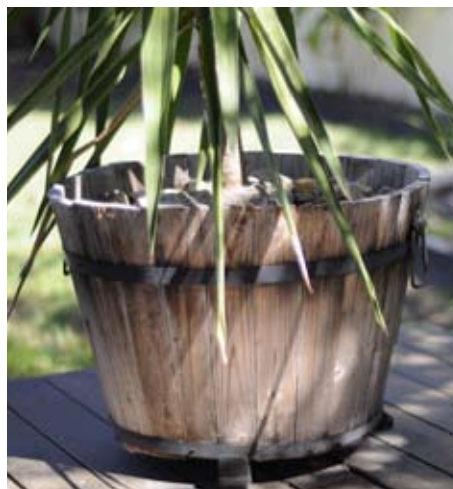
To reduce the likelihood of wet rot, any areas of the deck or balcony that are frequently damp should be addressed immediately. Dampness can occur when pot plants without bottom plates or feet are placed on the deck or balcony. Soil and other debris should also be cleared away from the deck or balcony, bearers or joists (if it is a low deck or balcony), and posts or supports.

Keep trays or feet under pot plants to reduce moisture on decking

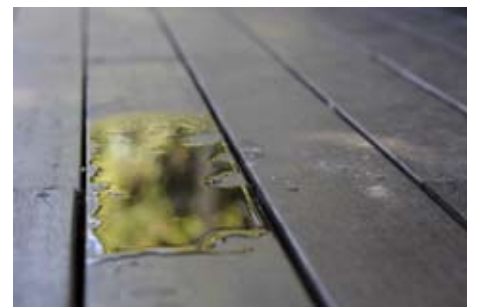
Water left on timber can cause fixings to deteriorate and rust

In these areas there is the potential for water to lay on horizontal surfaces such as bearers or joists, particularly where structures are enclosed.

Care should be taken to inspect these sections for decay.

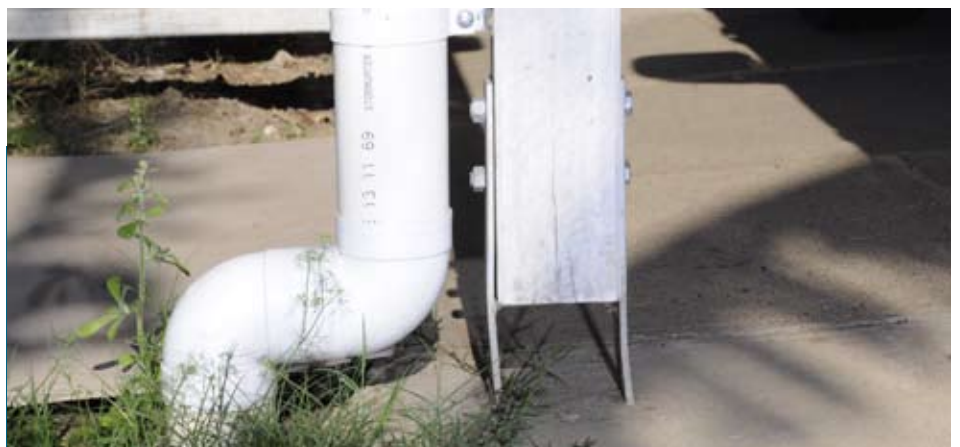
Bending or stress of post brackets—in most cases these brackets will be above ground level, which will make visual inspection easier.

Inspect post brackets for bending or stressing

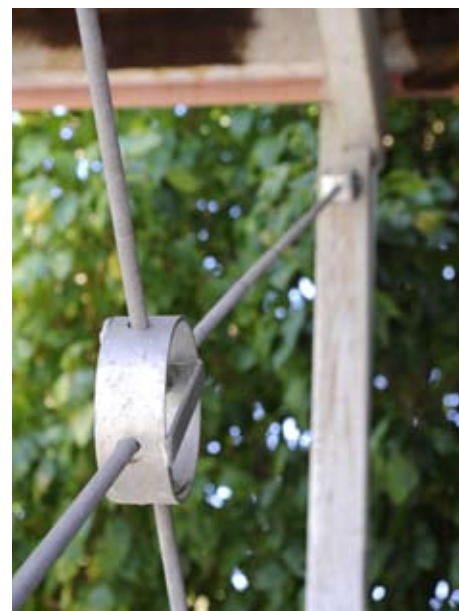
Bracing is often used to support a deck or balcony, helping prevent it from moving under load. Decks and balconies can come under considerable stress from swaying or twisting. If bracing fails, there is a significant risk of harm being caused to people and property. It is therefore important to inspect any bracing of a deck or balcony to ensure there has not been any excessive structural movement.

Inspect bracing on decks and balconies for undue structural movement

- warped, cracked or damaged bracing elements
- fixings that are coming loose or deteriorating.

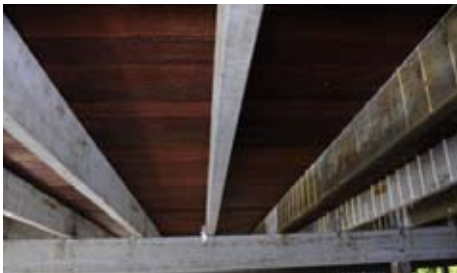
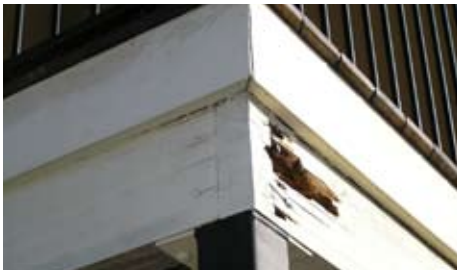
Bearers and joists are vital to the integrity of a deck or balcony. Bearers support the joists, which in turn support the decking. It is important that bearers and joists are in good condition and free from defects such as warping and cracking.

Check bearers and joists for warping or cracking

- warped, cracked or damaged bearers or joists.

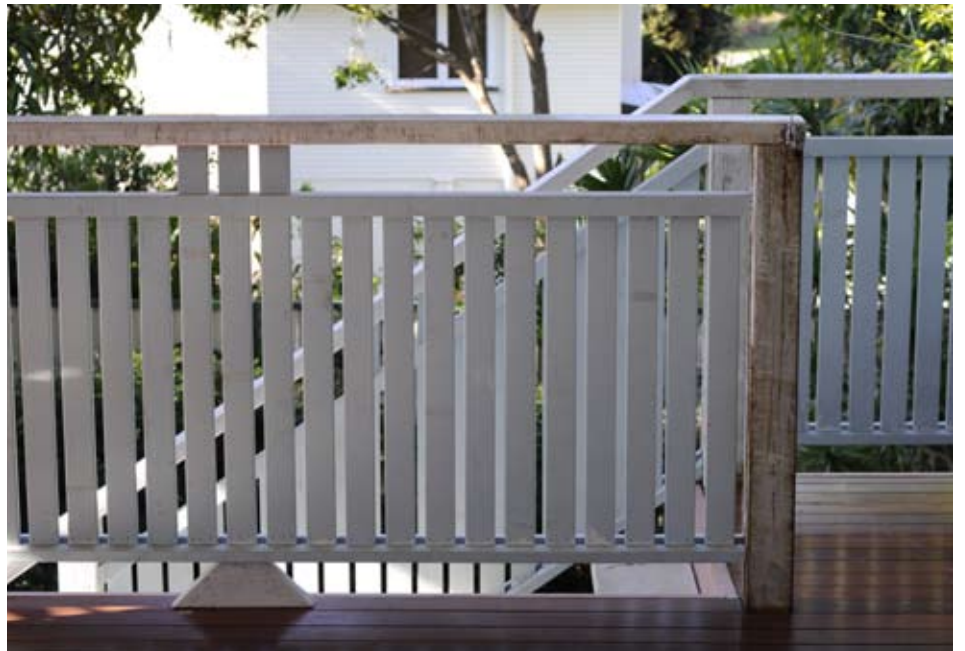
Anchor points of the balustrade should be inspected regularly to ensure these are free from deterioration. Any weakening of these anchors could cause them to fail if a load was applied to the balustrade, such as a person leaning against the balustrade.

Weakened anchors for balustrades could cause them to fail if people lean against them

- rust and wear at anchor points (where the balustrade is fixed to the deck or balcony, walls or posts)
- ensure the handrail is securely fastened to the balustrade
- check that any glass balustrades are free from chips or cracks
- openings in balustrade must comply with the relevant building regulations.
